NTSB ISSUES PRELIMINARY REPORT FOR AW139 ACCIDENT

NTSB issues the preliminary report into an accident involving an AgustaWestland AW139, N811TA, that occurred on September 24, 2022 at Houma–Terrebonne Airport (HUM/KHUM), Terrebonne Parish, Louisiana, that led to an Emergency Alert Service

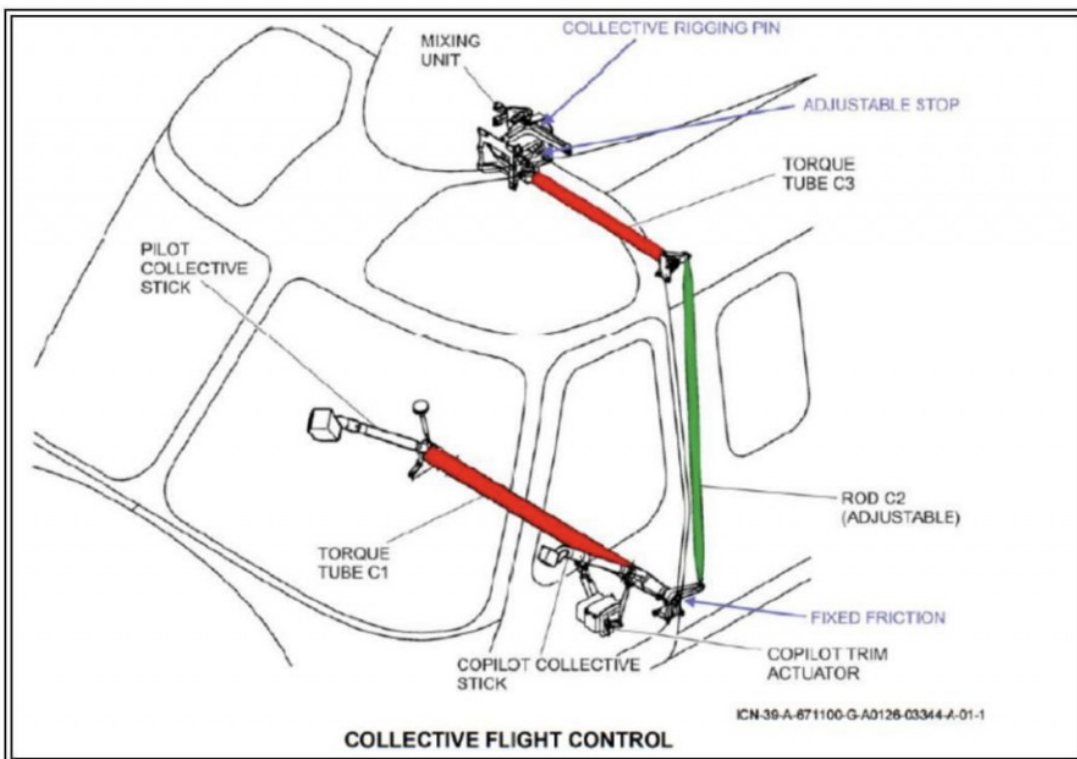
Figure 1: Collective Flight Controls

The pilot and copilot collectives are interconnected via the C1 torque tube located beneath the pilot seats, as shown in figure 1. A single control rod, C2, runs vertically up the left side of the helicopter behind the left-seat pilot where it connects through a linkage to the C3 torque tube that runs laterally above and behind the right-seat pilot to the mixing unit.

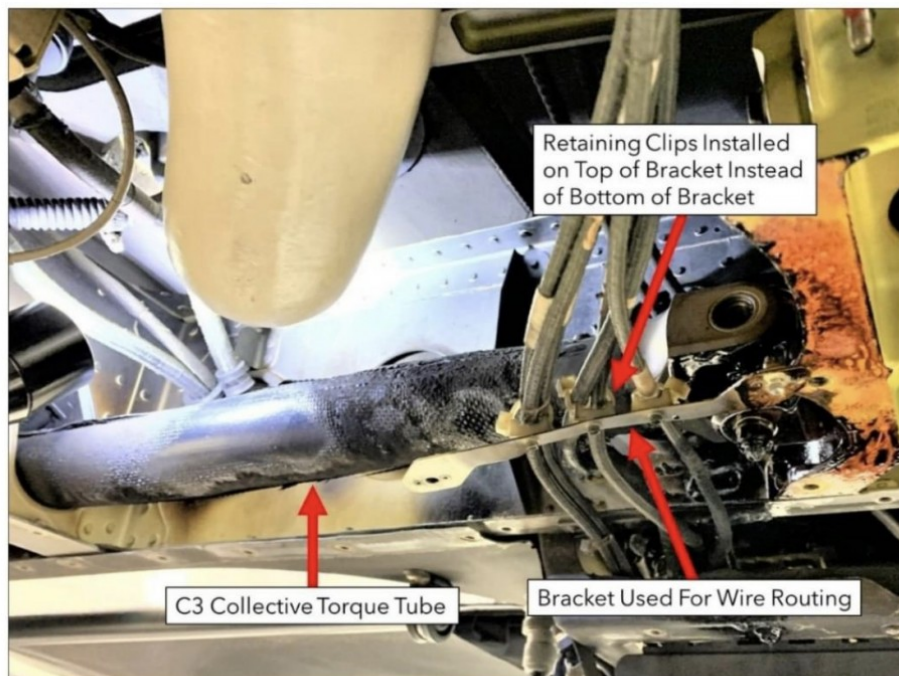
Figure 2: C3 Collective Torque Tube and Bracket Used for Wire Routing

A visual examination revealed thermal damage and a longitudinal split of the C3 torque tube, as shown in figure 2. The C3 torque tube was installed at both ends, with all fasteners installed and intact. A static test of the collective system without hydraulic pressure was conducted by moving the collective between the minimum and maximum pitch settings and observing the C3 torque tube. There was limited transfer of rotation between the pilot collective controls and the mixing unit because the outboard end of the C3 collective tube twisted while the inboard end by the mixing unit remained stationary; the C3 torque tube deformed torsionally along its length. Typically, the C3 torque tube does not rotate without hydraulic pressure.

The wire assemblies routed through the overhead to the overhead circuit breaker panels are intended to pass under support brackets; however, the accident helicopter had retaining clips installed on the upper portion of the left-side support bracket, as shown in figure 2. The chafed wire was secured by one of the retaining clips that was installed on the upper portion of the left-

side support bracket. Additionally, the right-side support bracket also had retaining clips installed on the upper surface, but there was no wire chafing observed.

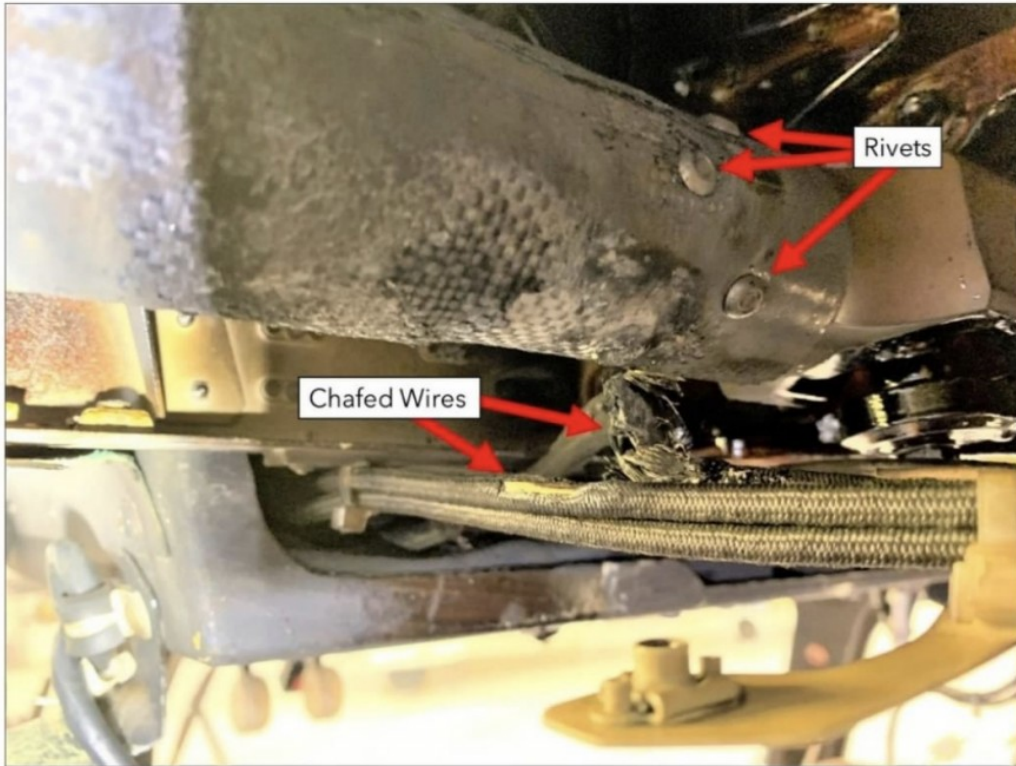
Electrical power to the helicopter is provided by two, 30 volt / 300 ampere direct current generators. Wire P190A6-G (p/n 3G9B11A1911) receives electrical power from the No. 1 generator through the T3 terminal on the No. 1 diode module and connects to the No. 5 distribution bar on the No. 1 essential bus in the cockpit overhead. Wire P190A6-G was found chafed through its insulation from contact with the C3 collective torque tube, as shown in figure 3. The chafed area was in-line with a rivet line running circumferentially on the C3 torque tube, as shown in figure 3 and figure 4. In addition to melted resin from the C3 collective torque tube, soot was found laterally along the entire overhead and on the panels that covered the C3 torque tube.

Figure 3: Chafed Wires and Rivets on C3 Collective Torque Tube

After the accident, on October 11, 2022, the helicopter manufacturer issued Emergency Alert Service Bulletin (ASB) No. 139-731 to require inspections of the forward cabin roof ceiling harnesses and their installation to identify potential wire chafing conditions. Specifically, the ASB required a borescope inspection to identify if the cable assemblies were incorrectly routed above their respective support brackets. If a cable assembly was incorrectly routed above a support bracket, then the ASB required additional examination of the cable assembly for evidence of wire chafing and damage to the collective C3 torque tube. Any support bracket with retaining clips incorrectly installed on the upper surface are to be removed from service and replaced with a support bracket manufactured with retaining clips installed on the lower surface to ensure proper routing of the cable assemblies beneath the support bracket. Finally, the ASB required a visual inspection of the cable assembly adjacent to the No. 1 diode module (Diode A77) for chafing and damage, and to ensure there was at least 10 mm of clearance between the cable harness and the diode module.

On October 12, 2022, the European Union Aviation Safety Agency (EASA) issued Emergency Airworthiness Directive (AD) No. 2022-0209-E based on the helicopter manufacturer's Emergency ASB No. 139-731. The Emergency AD required a borescope inspection of the cable installation inside the forward cabin roof ceiling within 10 flight hours, and a visual inspection of the cable assembly adjacent to the No. 1 diode module (Diode A77) for chafing and damage within 25 flight hours.

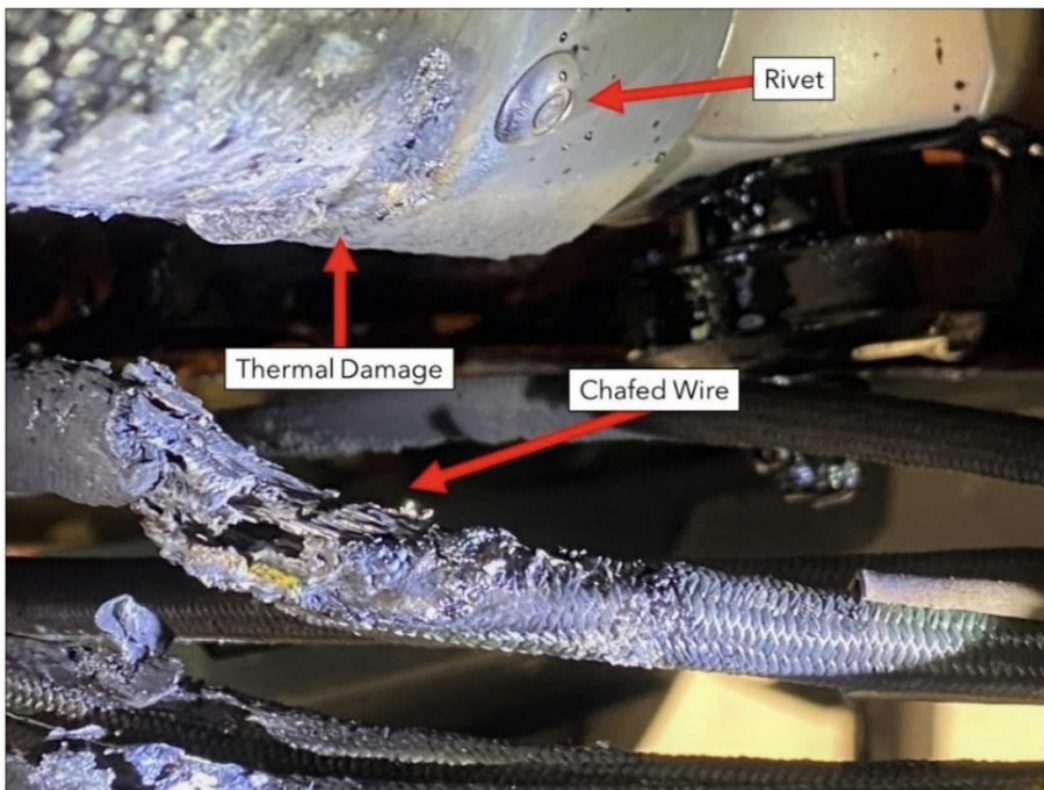
Figure 4: Chafed Wires and Thermal Damage to C3 Collective Torque Tube
